MAINTENANCE BULLETIN

AN/TPQ-37 (V4) ANTENNA TRANSCEIVER GROUP	FILE NO: 141	REVISION:
	DATE: 9/5/91	CATEGORY: D-SAFETY
SUBJECT: MISSING SLEEVING INSULATION ON BSU AND RECEIVER EXCITER POWER SUPPLY CONNECTOR CONTACTS	SYSTEMS AFFECTED: 89-99 (FMS ONLY)

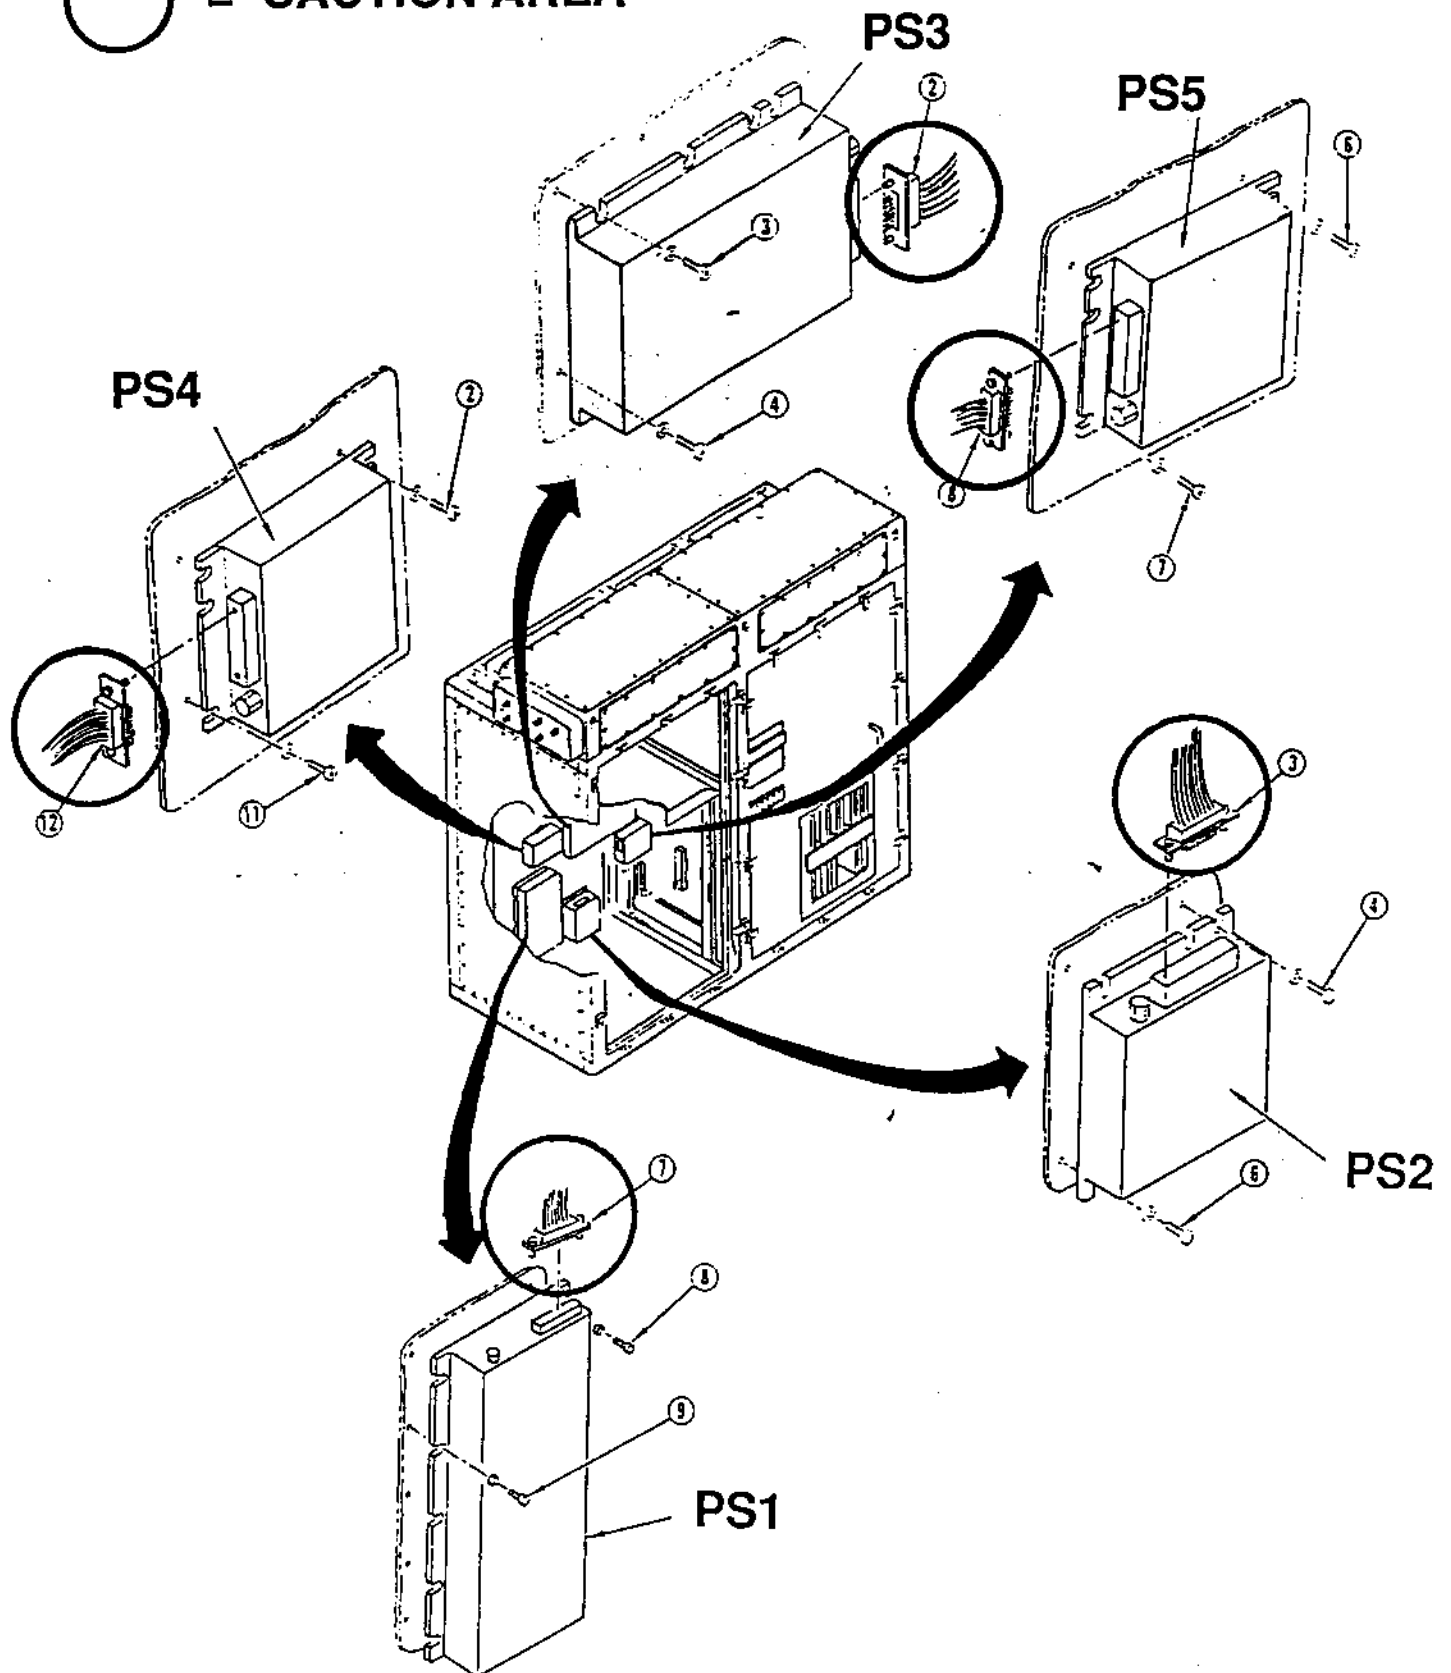
RECEIVER EXCITER POWER SUPPLIES

2. PURPOSE: The purpose of this SAFETY Bulletin is to alert the users of missing insulating sleeving on Beam Steering Unit (BSU) and Receiver Exciter Power Supply connector contacts. These exposed wires carry system AC Power (115V, 400Hz) as well as DC Power (-5 to 100V), thus presenting a possible SAFETY hazard when maintenance is being accomplished within the vicinity. Enclosed for ease of identification of the area within the BSU (P420, P421, P422, P423, P424, P425, P426, and P427) and Receiver Exciter (P9, P10, P11, P12, and P13) affected, find art work that has been extracted from reference in paragraph 1 above.

3. SAFETY PRECAUTION. A reminder to technical personnel to de-energized the System per TM 11-5840-355-10-1, Operator's Manual while components/assemblies

4. CORRECTIVE ACTION: The long term corrective action to alleviate above problem is now under consideration. After the final solution to this problem is arrived at, detailed documentation will be forwarded to the field for implementation.
